NVR - Channel Connection

Adding IP Cameras Failed

[NVR - Channel Connection] Adding IP cameras failed

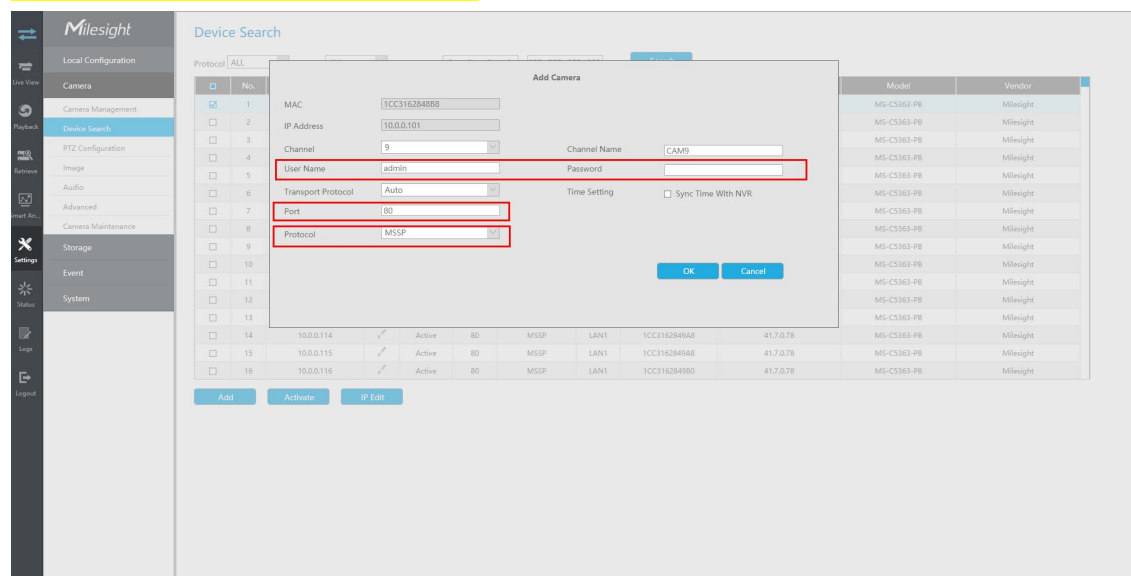
To successfully add the camera to the NVR, these 4 key parameters must be correct, which include **username, password, port and protocol type** as shown below:

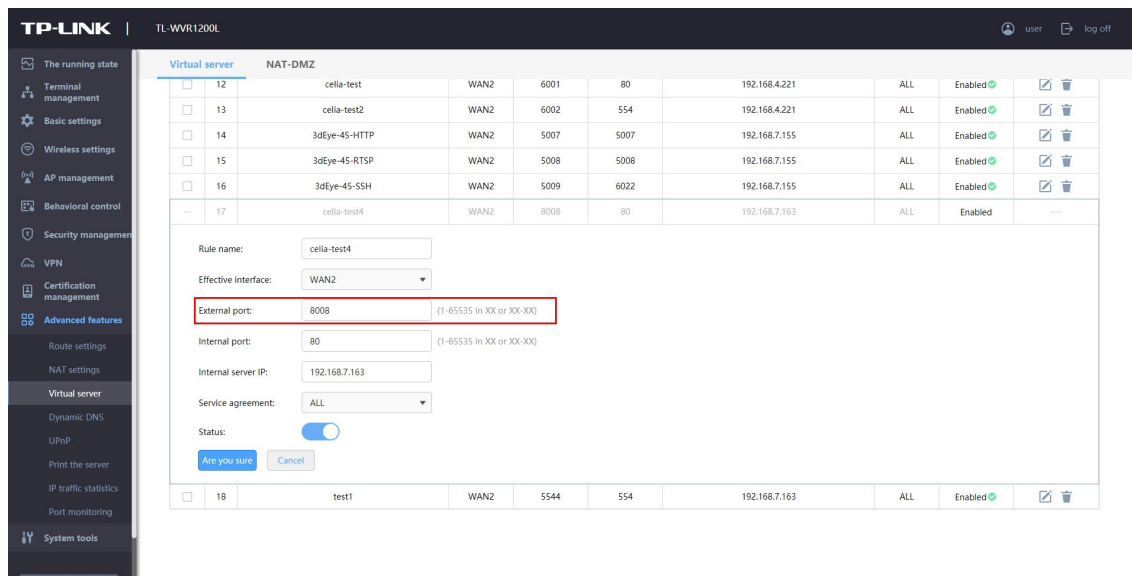
- UPnP is Enabled

You need to input the **corresponding External Port of UPnP**. For example, you need to input 3346 on the NVR side when the UPnP settings as shown below.

- UPnP is Disabled

You need to input the **corresponding External Port of router**. For example, you need to input 8008 on the NVR side when UPnP is disabled and router settings as shown below.

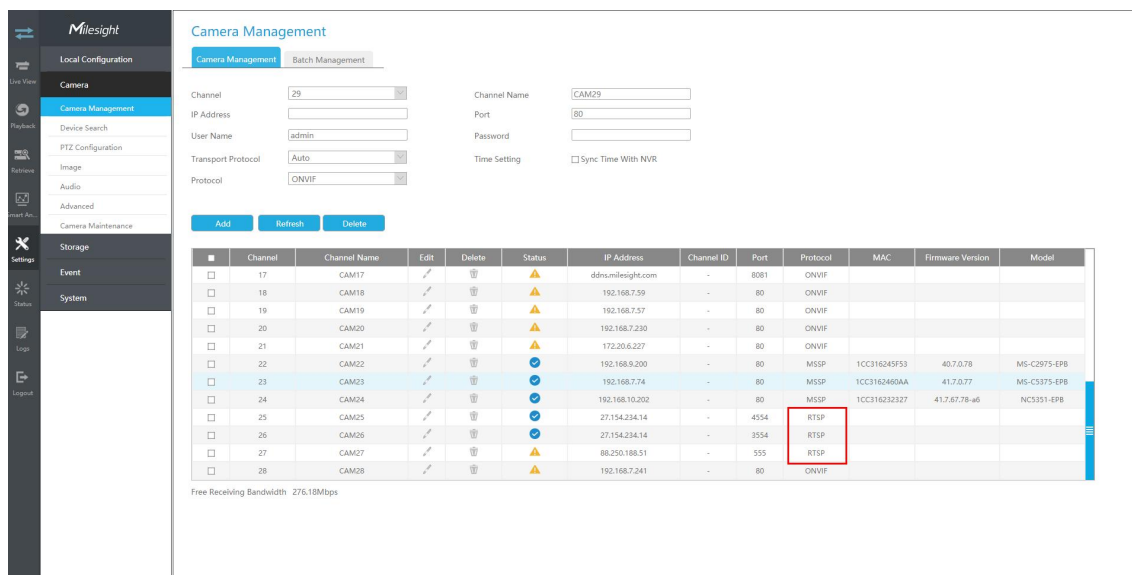
If you want to play RTSP stream, you need to select RTSP protocol.

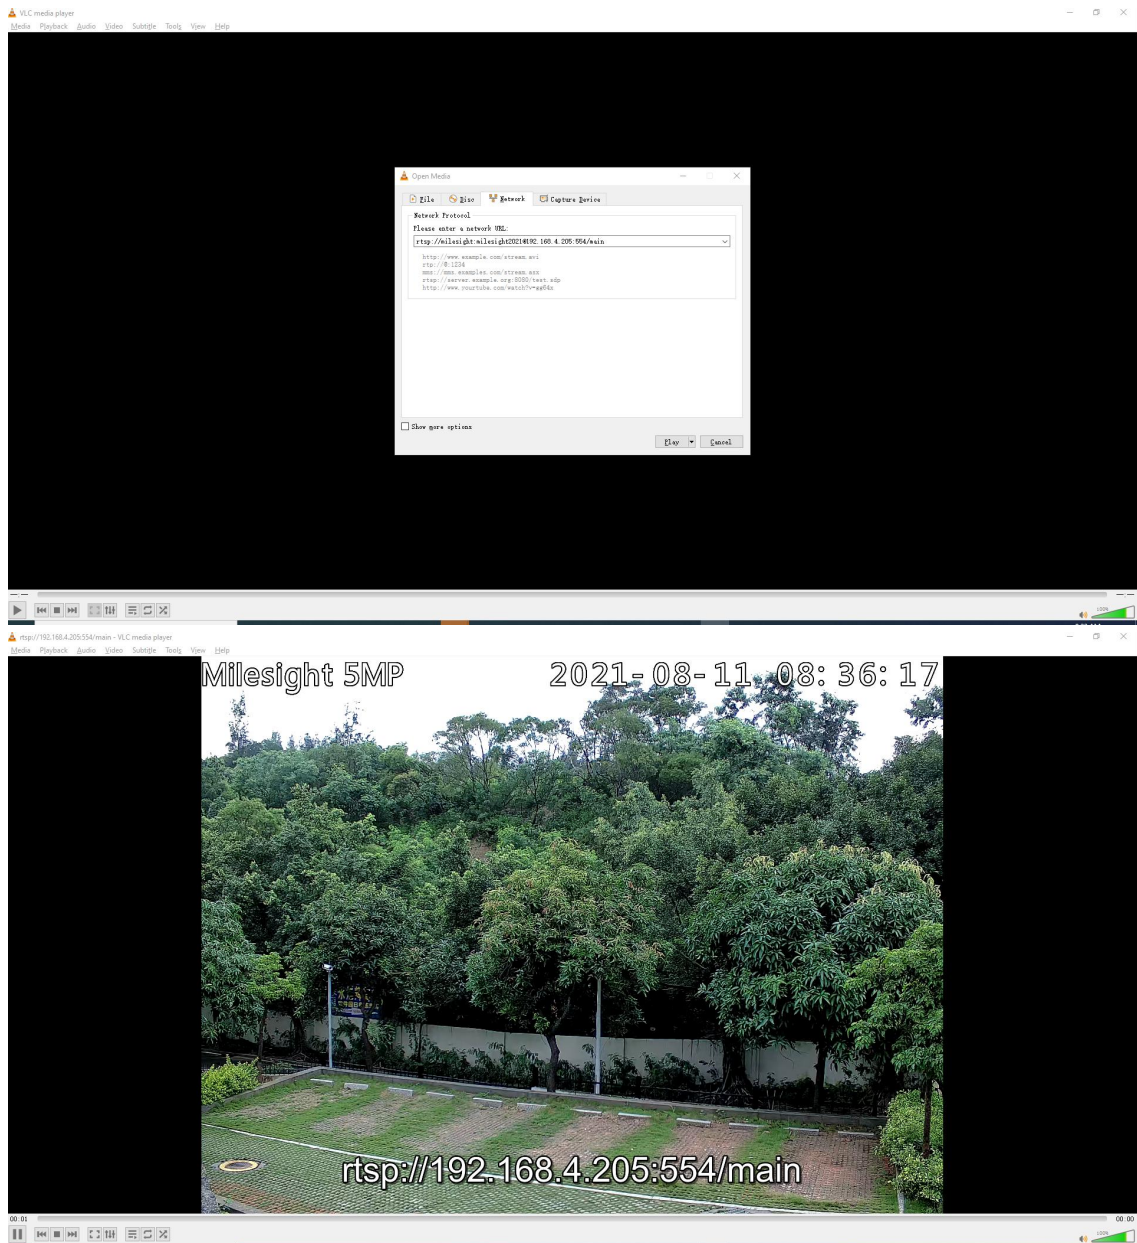
- Also, you need to check whether the RTSP stream is normal. Ensure the RTSP stream of camera is available. You can test it via VLC player as shown below:

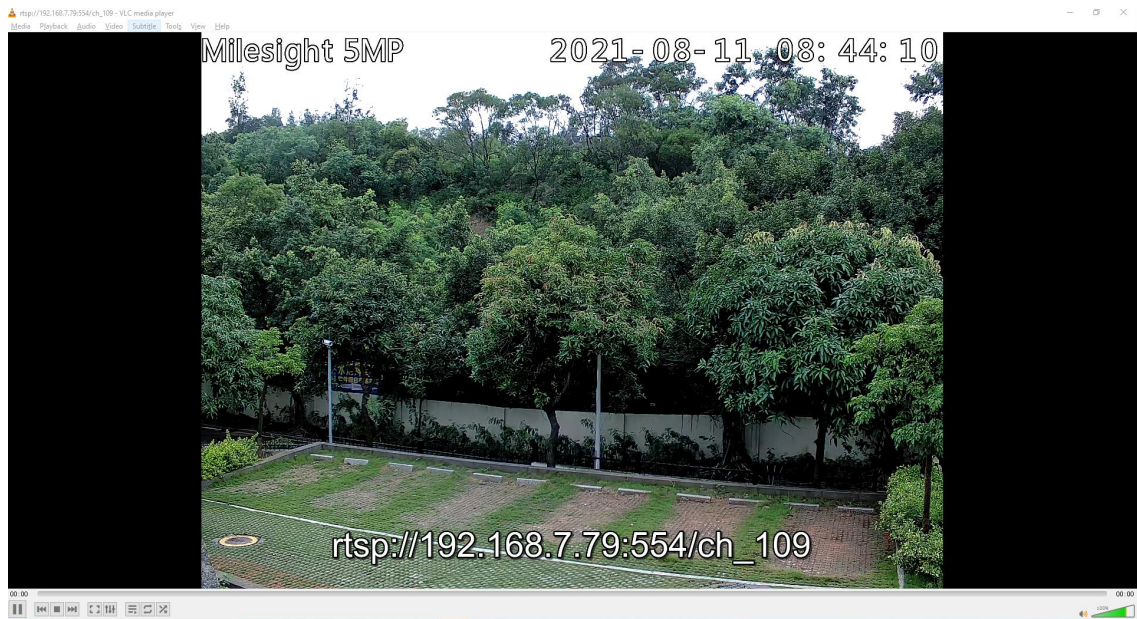
Ensure the RTSP stream of NVR is available. You can test it via VLC player as shown below:

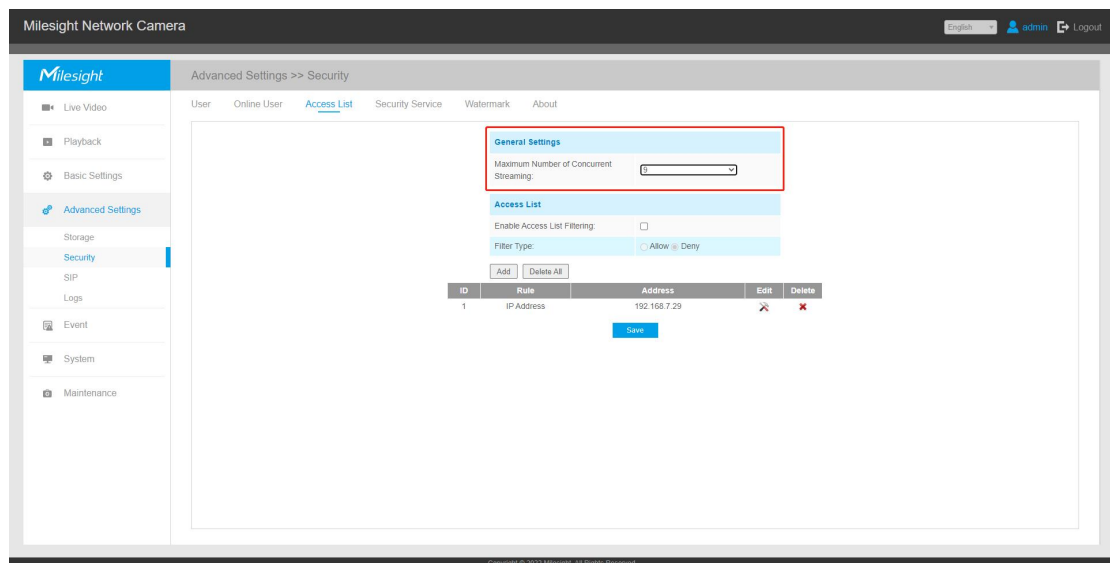
2.2 Maximum Number of Concurrent Streaming on the Camera side

Ensure the number of camera connections reaches the Maximum Number of Concurrent Streaming.

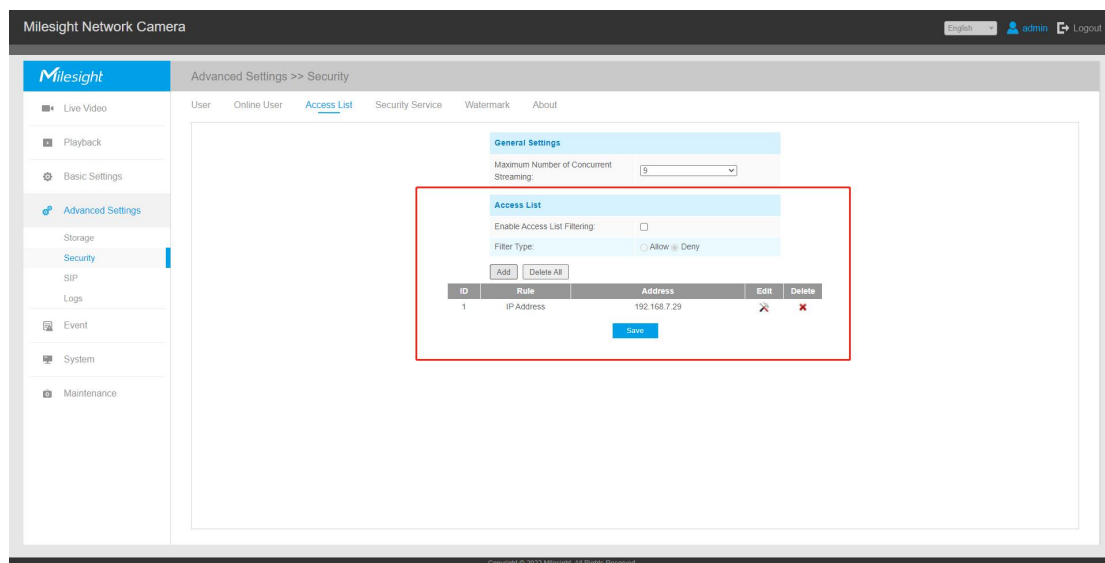
2.3 IP Access List at camera side

Check whether the cameras are online and the IP access of the NVR has been restricted on the camera side.

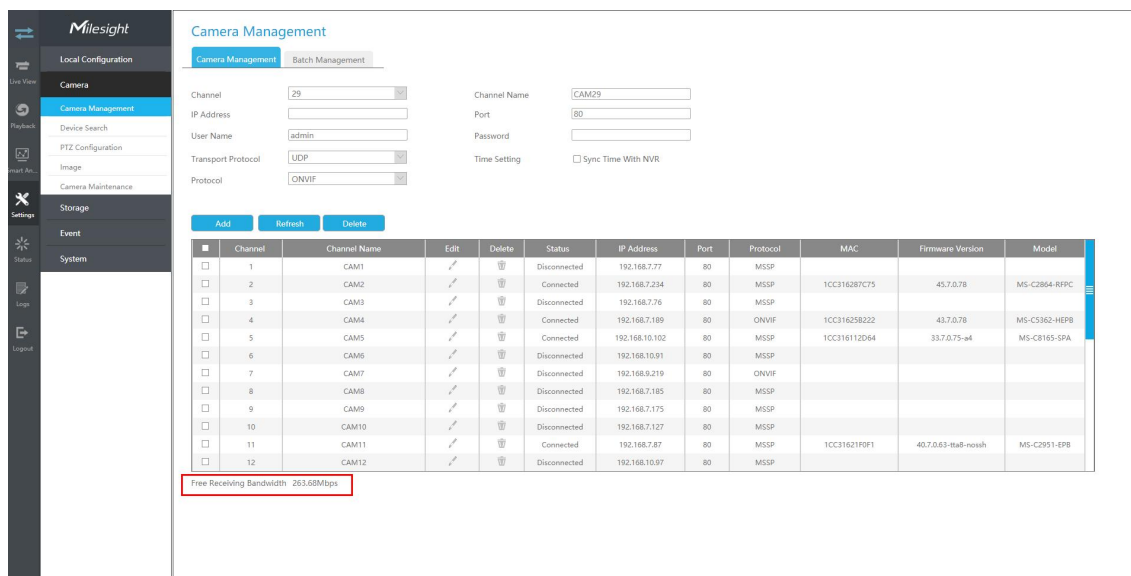
2.4 Free Receiving Bandwidth on the NVR side

Ensure that Free Receiving Bandwidth has enough bandwidth on the NVR side. In some cases, the cameras will display “Disconnected” if the Free Receiving Bandwidth is not enough even though the Live View can play normally.

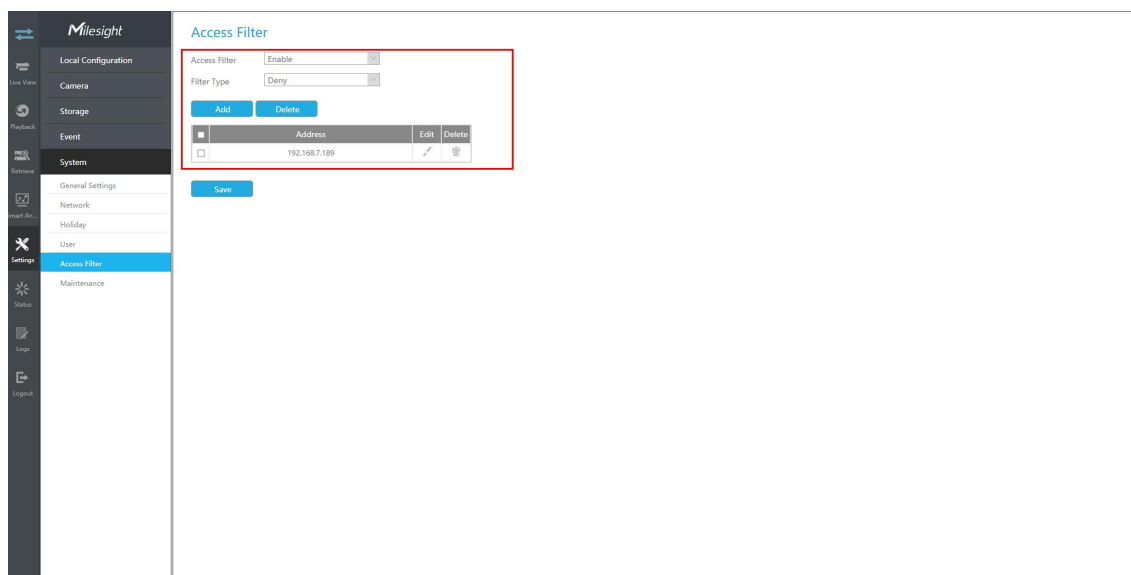
2.5 Access Filter on the NVR side

Check whether the IP/MAC access of the cameras have been restricted on the NVR side.

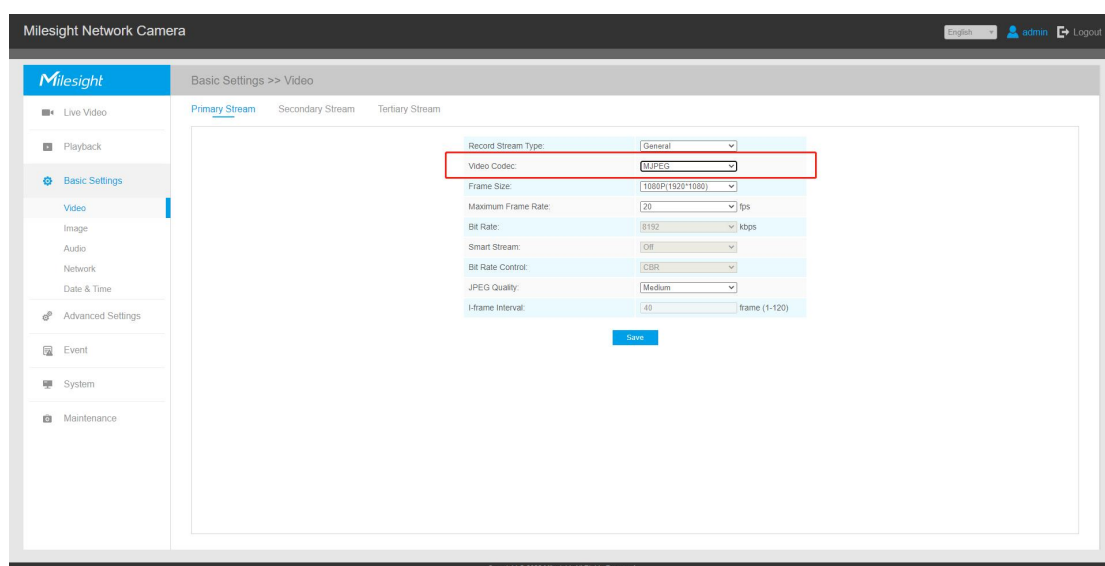
3.1 MJPEG Video Codec Type

Due to NVR doesn't support MJPEG video codec Type, please check the Video Codec on the camera side.

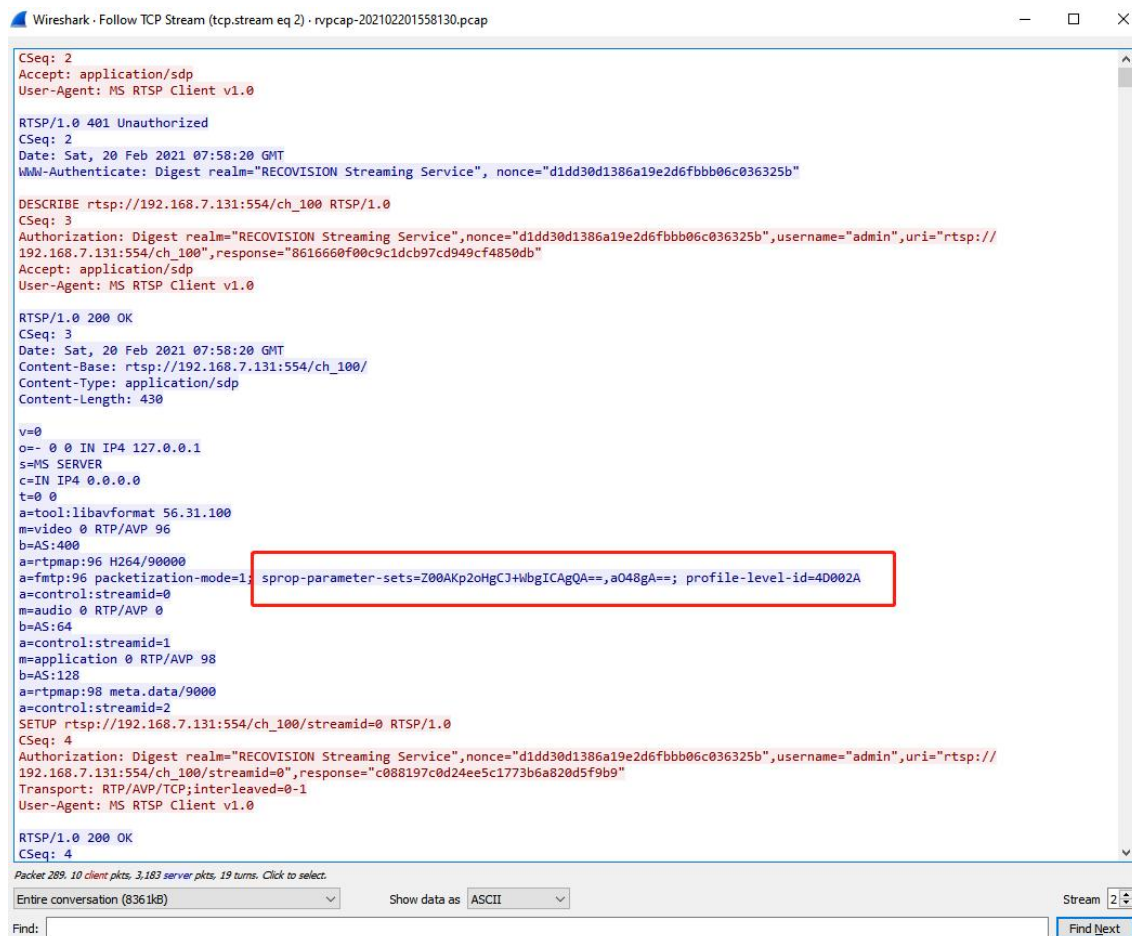
1. The preview failure problem when adding channels of the NVR to another NVR via RTSP.

Cause: The old version is not compatible with Milesight NVR that does not carry sprop-parameter-sets.

Resolution: Upgrade NVR firmware version to **7X.9.0.12 (2021/6)** or above.
