NVR - Local & Web Live View

Fuzzy Screen Images

[NVR - Local & Web Live View] Fuzzy Screen Images

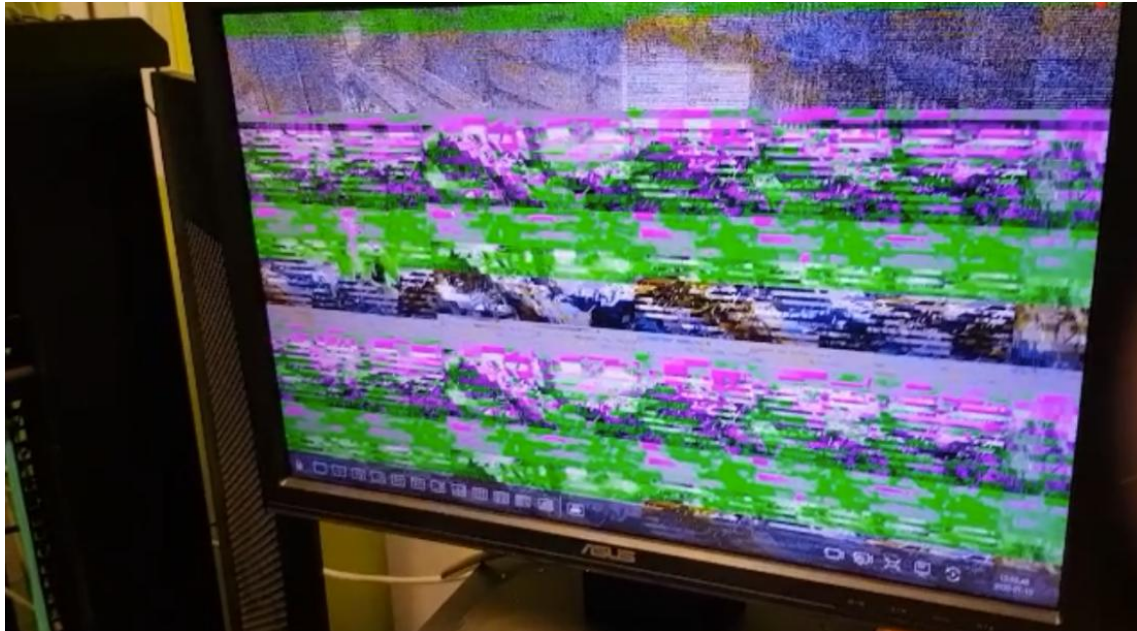
Local Monitor:

Fuzzy Screen Images **of channels** on Live View page. Fuzzy Screen Images contains Image broken, Distortion, Blur, Green screen, etc.as shown below:

Before starting troubleshooting the image broken issue, we strongly recommend that the NVR firmware be upgraded to the latest version, which will optimize the transport protocol automatically.

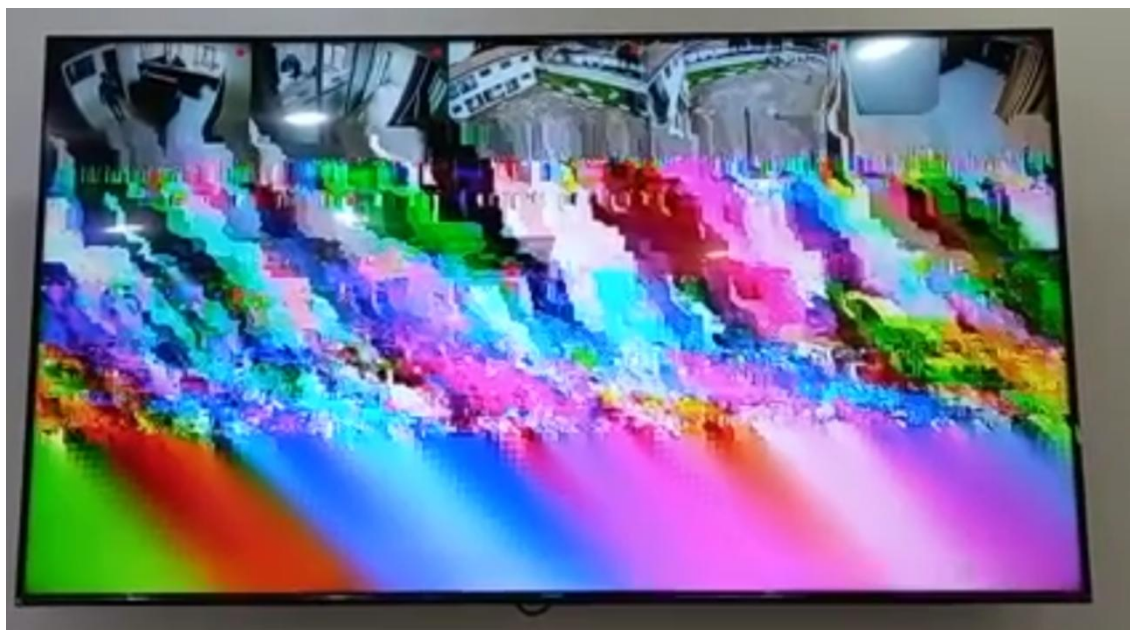
If the problem ONLY occur on Local Monitor but other sides are normal, we need to consider whether the video cable is good.

As you can see below picture, the entire screen image is blurred. In this case, you can try to exchange good HDMI/VGA cable to test if the problem is solved.
