NVR - Third-Party Integration

Adding Third - Party IP cameras failed

[NVR - Third-Party Integration] Adding Third-Party IP cameras failed

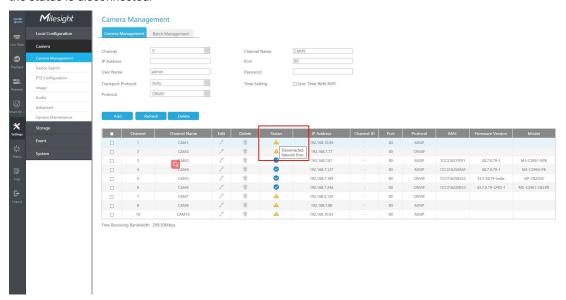
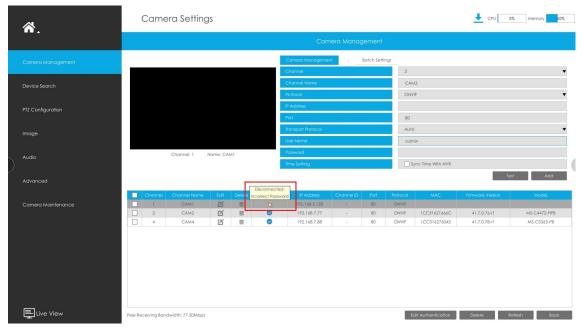
The Third-party IP cameras are successfully added and displayed on the Camera Management list, but the status is disconnected.

We recommend updating the NVR firmware to the latest version before starting. The latest version can be downloaded from the <u>Download CenterlMilesight</u>.

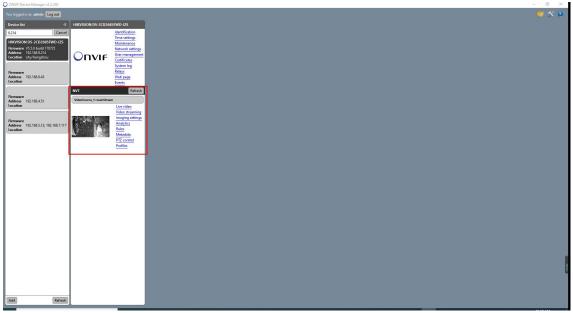
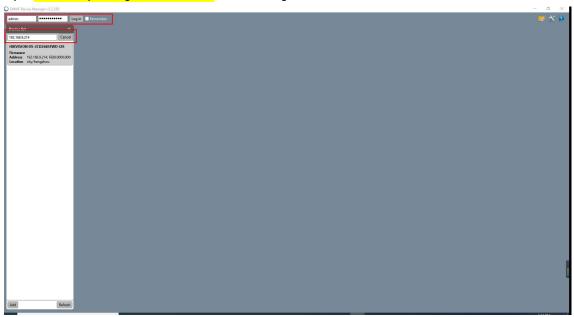
- Ensure the camera can be detected by ODM. It represents the camera supports ONVIF.
- Ensure that the camera can be added via ONVIF. Check whether the NVT will display the camera information normally after logging in.

Input the corresponding ONVIF account and click Log in.

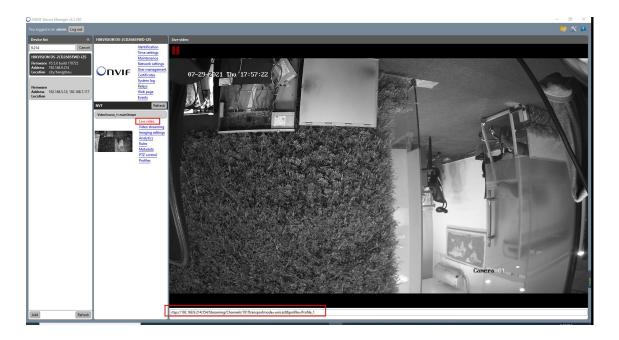
• Ensure the RTSP stream is available. Check whether the video stream can be played normally after the camera is successfully added through ONVIF.

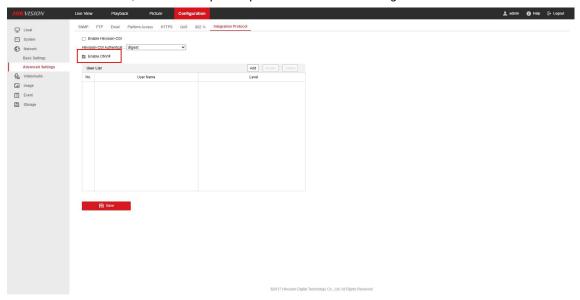
1.2 ONVIF Protocol is NOT Enabled

For most of IP cameras, ONVIF is an optional protocol as shown in the figure below:

Ensure the ONVIF is Enabled.

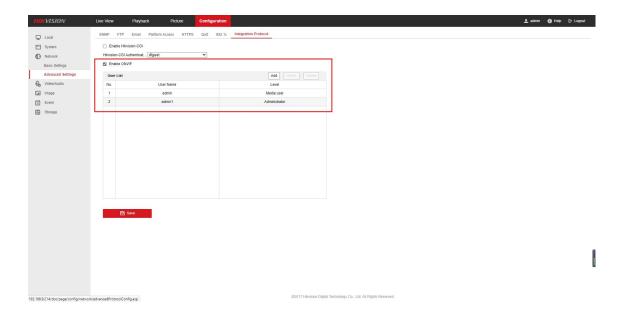
1.3 No ONVIF Account

Some third-party brand IP cameras, such as HIKVISION, needs to add ONVIF account but there is no default one. You need to Enable ONVIF and add ONVIF accounts. For example, you can add this camera to NVR through either of these two ONVIF accounts as shown below:

Ensure there is at least one ONVIF account available.

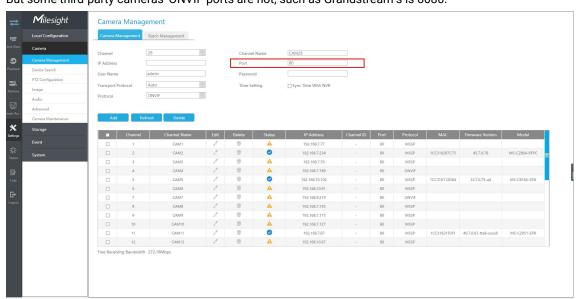
1.4 Incorrect ONVIF Port

In most cases, the port of ONVIF is 80, so the default port value of Milesight NVR ONVIF protocol is 80. But some third-party cameras' ONVIF ports are not, such as Grandstream's is 8080.

Check the ONVIF port of camera. Ensure the filled ONVIF port is correct.

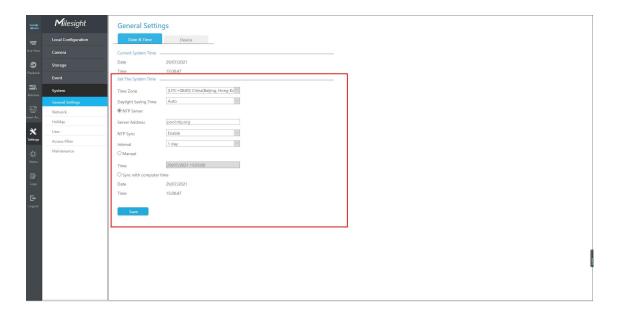
2.1 Camera and NVR Time Synchronization

For some third-party brands, like Axis cameras, you need to check whether the time is synchronized with the NVR, because this brand's camera has time synchronization requirement.

Ensure the system time of camera is the same as NVR.

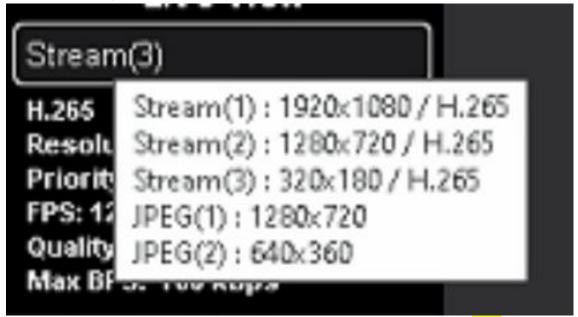
Due to Milesight NVR only supports H.264, H.265 video codec type, please pay attention to the camera's MJPEG, H.264+, H.265, H.265+ and smart stream options.

Regarding the video codec type, here is an example: For Panosonic camera, some of them don't support H.264 video codec type as shown below.

Considering that H.265 may have compatibility issues, H.264 is recommended. If you need to be compatible with H.265, please contact Milesight technical support for help.

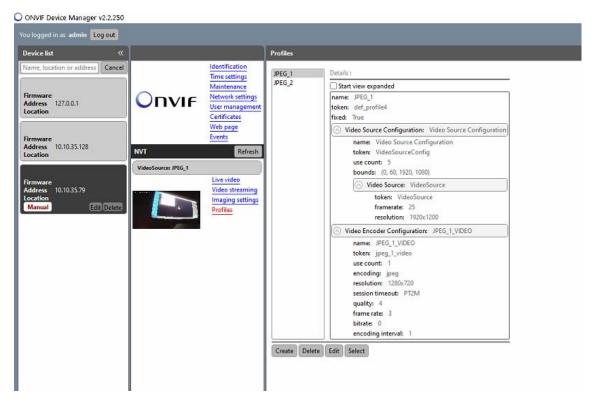
Even choose the Stream 1-3 (H.265), Panosonic camera still get response from ODM of JPEG video codec type.

As you know, Milesight NVR doesn't support MJPEG video codec type which proves that these cameras cannot be added to Milesight NVR. Also, about H.265 responding to JPEG, you need to contact Panosonic technical support for help.
