# Milesight-Troubleshooting Lightning Protection

Version 1.00	Update	2021.02.22
--------------	--------	------------

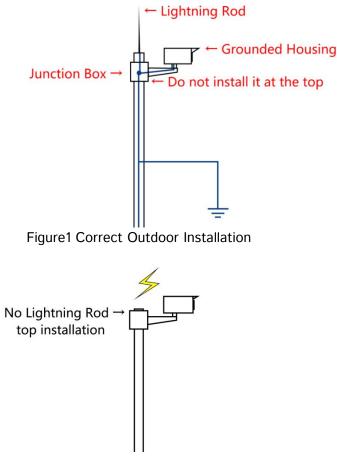
Figure2 Incorrect Installation

- Installed on the pole, the camera should not be at the very top. Slightly move it down, or it is easy for the camera attract lightning.
- It is better to have a lightning rod at the top of the pole.
- the camera housing should be grounded.
- In theory, it would be better to add a Junction Box, so the tail wire can better avoid lightning with a shell protection.
- If possible, deploying lightning arrester on site, especially in coastal areas where there are often thunderstorms.
