Milesight-Troubleshooting

Common causes of LPR data push failures to Milesight NVR

Version	V1.0	Update	2023.9.13
---------	------	--------	-----------

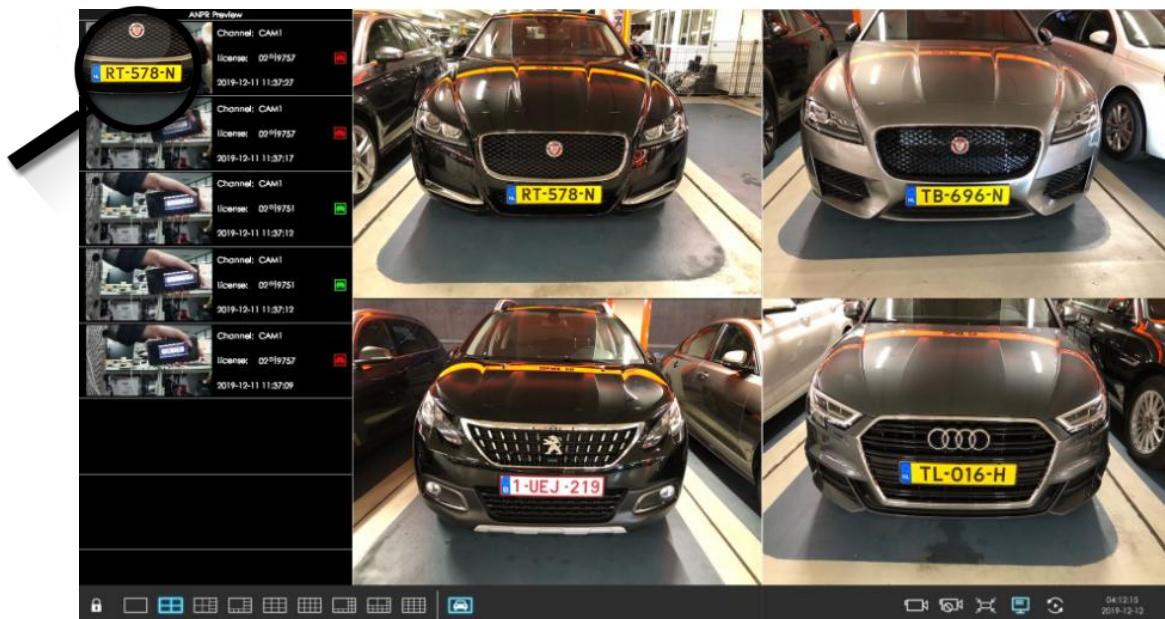
1. The local monitor cannot display license plate information after turning on the **target mode**.

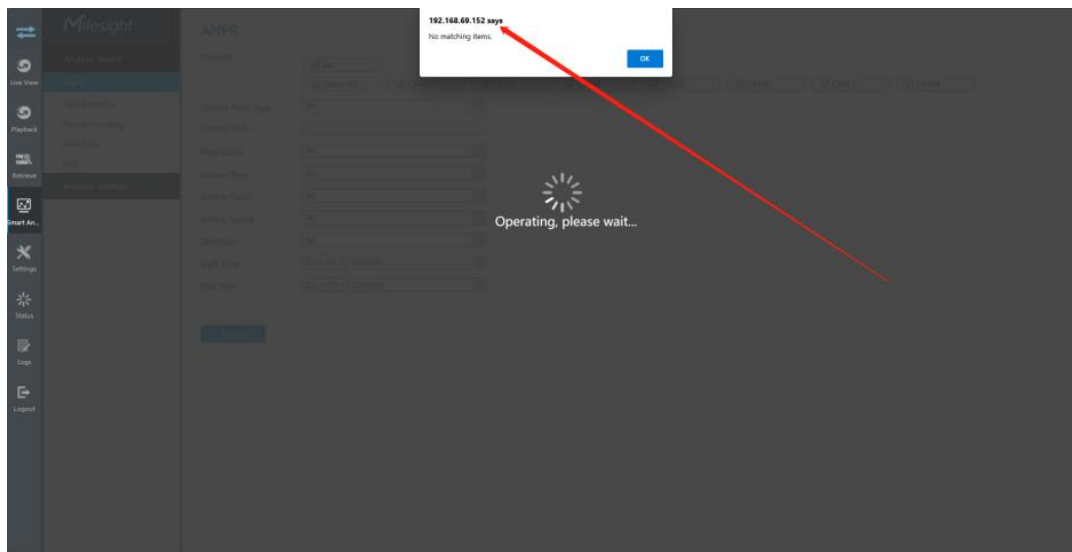
2. ANPR Search cannot search for relevant license plate information.

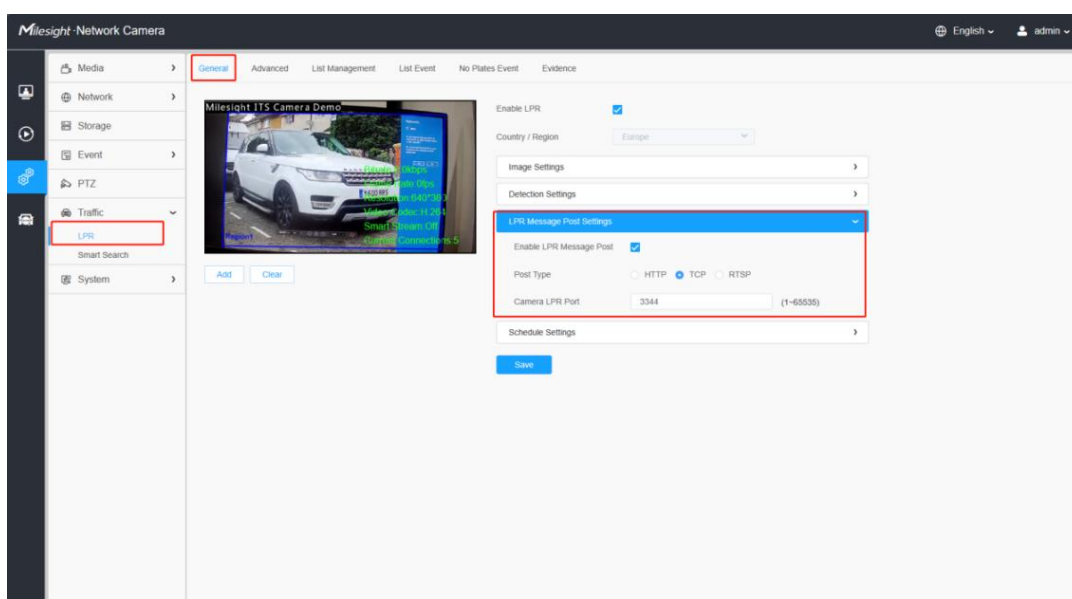
1. The LPR Message Post mode is not set correctly

LPR message post supports HTTP/TCP/RTSP three methods, but they cannot take effect at the same time. Only when set to TCP mode, the NVR can receive the license plate data sent by the ANPR Camera. Please set **TCP** as Post Type which is the default mode.

It can be set in Camera web page -> **Traffic** -> **"LPR"** -> **"General"** -> **"LPR Message Post Settings"**.

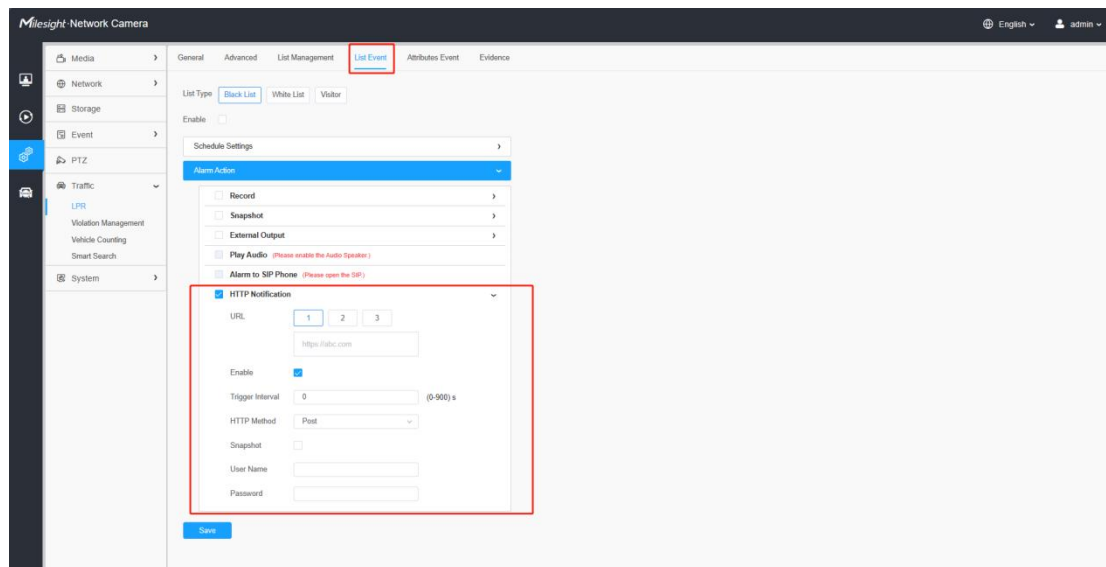
- 1.The HTTP notification Post method is only supported on the TS series PE platform and the latest version T_61.8.0.3-XX-r7 camera, for example: TS2866-X4TPE;
- 2.Other models default to the get mode, and the notification only carries the license plate number.

it is recommended that you use TCP to transmit to Milesight NVR, and use HTTP notifications in list events to transmit license plate data to the third-party server.

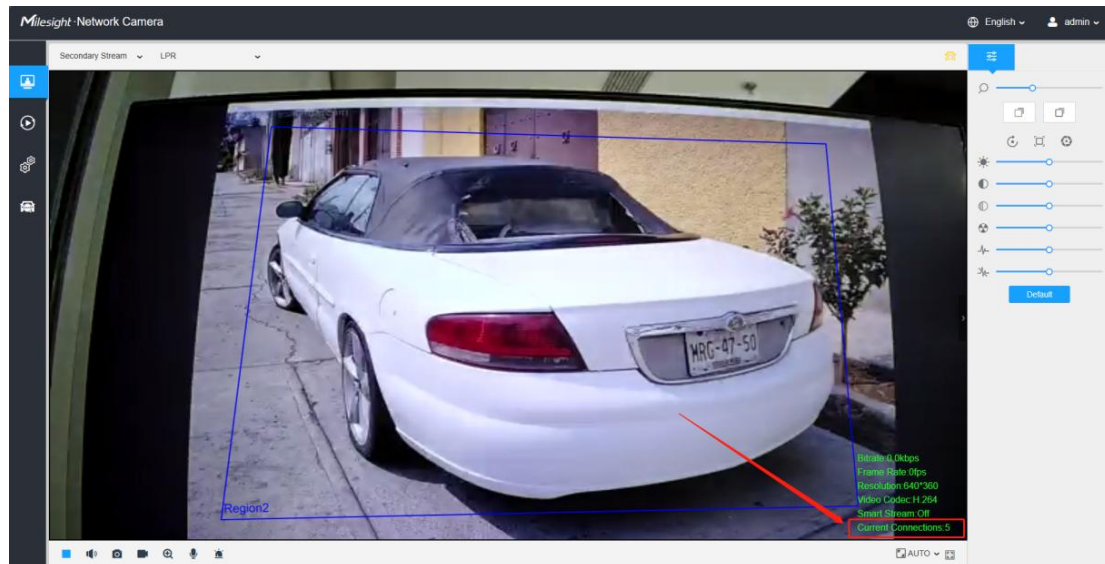
The TCP connections of the ANPR camera are limited to 5. When there are multiple back-end devices connected, the excess devices will not be able to receive data, you can try to change

You can view information on the number of currently connected devices from the ANPR camera live view interface. Usually each Milesight back-end device will occupy 2 stream connections.

the Camera password and add it again. Or try to delete the ANPR Camera from other devices to verify the problem.

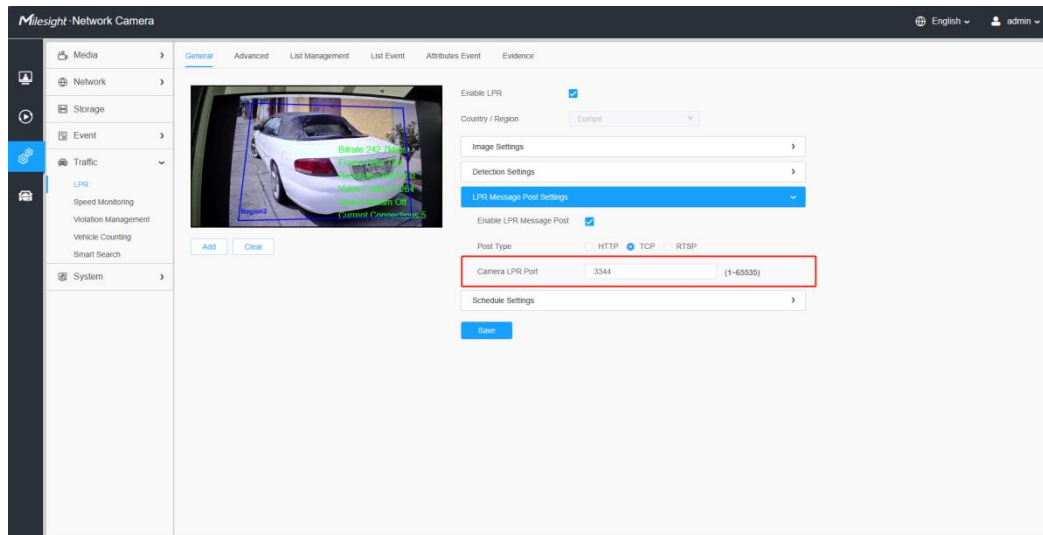
4. LPR data posting port is abnormal

Milesight NVR supports adding ANPR Cameras for management through public IP address. If you use public IP address to add and map multiple ANPR cameras at the same time, please make sure that the TCP port of each ANPR Camera has been mapped separately.

The post port can be manually modified to ensure that the port is not occupied effectively.
