NVR - Local & Web Live View

Fuzzy Screen Images

[NVR - Local & Web Live View] Fuzzy Screen Images

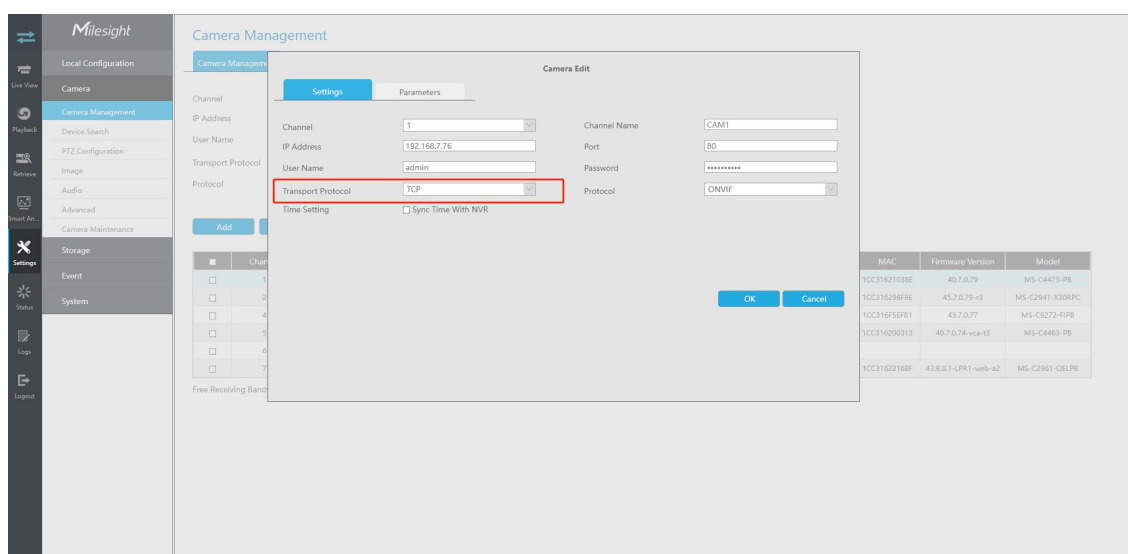
1.1 Transport Protocol

Compared with UDP, TCP is reliable as it guarantees the delivery of data to the destination host. It can effectively reduce the probability of image broken.

Make sure the Transport Protocol is TCP.
